» PERISTALTIC PUMP REPAIR (FOR THE FOOD AND BEVERAGE INDUSTRY)

Overview: A customer in the food and beverage industry pumping mint sauce concentrate came to us with an Albin Peristaltic Pump. The customer had reported that they were experiencing issues with a lack of performance and flow rate. We started by insulation testing the motor winding using a calibrated CAT III mega meter, and all three windings exceeded the insulation minimum reading. Following this, we washed the pump down and drained the oil from the pump casing. The oil was slightly discoloured, the hose was misshapen and slightly flattened, having lost some of its elasticity which would have reduced its volume and pumping capacity.

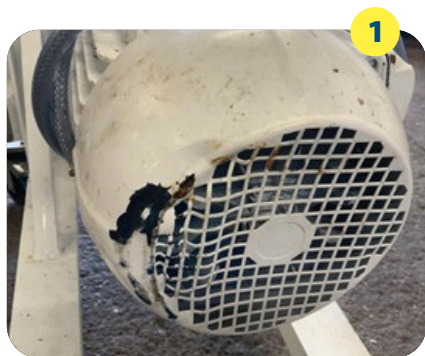
Damaged fan cowl

Above, you can see the damaged fan cowl and the presence of the metal shavings from the hub taper lock which had settled in the shaft key.

For the pump to return to its peak performance, it was recommended that a new hose and hub assembly be renewed. It would also be wise to replace all the seals, seal sleeves and O rings, and refill the pump with fresh oil. It would also be advised that the end-user check for any restrictions in the pump delivery pipework which

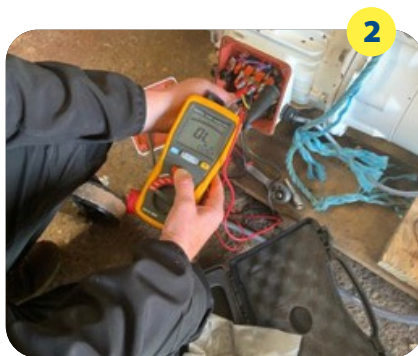
Taking insulation readings from motor windings.

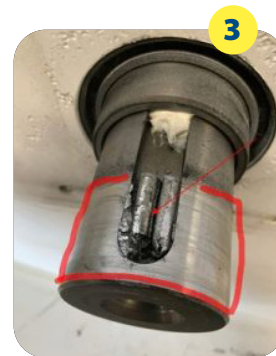
Damaged Hub Taper Lock

After dismantling the pump further, the screws in the hub were extremely loose. After the wheel was removed, it could further be seen that the wheel had been stalling while the transmission shaft had continued rotating in the hub. This then resulted in the metal shaving off the hub taper lock, which had settled in the shaft keyway and to the rear in the hub. This would have also contributed to the discolouration of the oil and explained the looseness of the screws, as well as the loss of flow from the pump.
